Status of Thermal NDT of Space Shuttle Materials at NASA

ABSTRACT

Details of the analysis technique that has been developed to allow *insitu* inspection of a majority of shuttle RCC components is discussed. Additionally, validation testing, performed to quantify the performance of the system, will be discussed. Finally, the results of applying this technology to the Space Shuttle Discovery after its return from the STS-114 mission in July 2005 are discussed.

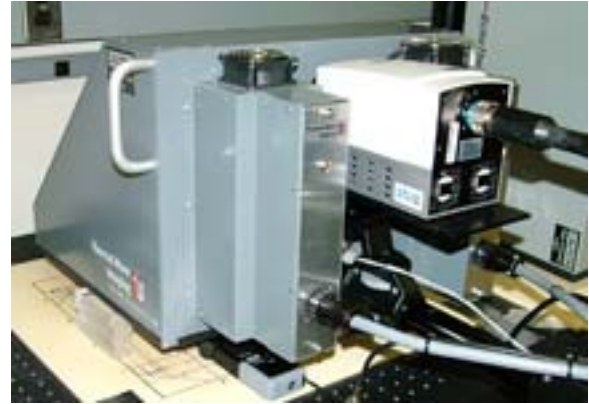
Figure 2 – Photographs of the two hoods used with the EchoTherm® thermography system. (a) “Straight” hood and (b) “Right angle” hood.

The flash thermography system for this inspection is the commercially available Echotherm® system from Thermal Wave Imaging (TWI). The system features one of two hoods, both containing a 320 x 256 Phoenix® infrared (IR) camera with two 4800-Joule xenon photographic flash tubes. The first hood is a “straight” hood typically provided with the commercial system. This hood (shown in figure 2a) has dimensions of 36.8 cm wide by 26.7 cm deep by 40.6 cm tall and is configured such that the IR camera views the inspection surface directly. When the Phoenix® camera is added to the back of the flash hood the total height of the inspection system (maximum clearance needed from the inspection surface) is increased to 71.1 cm. The flash of the “straight” hood produces a flash energy density of 7.15 joules per square centimeter at the mouth of the hood. This was calculated from the final temperature increase of a 0.635 cm thick sample of RCC and the nominal thermal properties of RCC. The flash of the “straight” hood flash lamps provides a uniform illumination within 10% across an area of 24.8 cm x 32.7 cm of a flat reference standard at the mouth of the hood as determined from measurements of the temperature rise of the RCC material.

Because of OPF clearance limitations it is necessary to have a custom “right angle” hood built to accommodate *insitu* inspection of the orbiter wings. The “right angle” hood (shown in figure 2b) has dimensions of 43.2cm wide by 36.8 cm deep by 34.3 cm tall and is configured such that heating and imaging of the inspection surface is accomplished by reflecting off a mirror mounted at 45° to the surface. The “right angle” hood produces a flash energy density of 6.0 joules per square centimeter at the mouth of the hood. This was calculated from the final temperature increase of a 0.635 cm thick sample of RCC and the nominal thermal properties of RCC. The flash of the “straight” hood flash lamps provides a uniform illumination of within 7.3% across an area of 24.8 cm x 32.4 cm of a flat reference standard at the mouth of the hood as determined from measurements of the temperature rise of the RCC material.
